## RUGBY WATER TANK

When engineers hired by Rugby, North Dakota, found the town's elevated water tank pitted and leaking, they decided it was time to "trade up" to a new 250,000 gallon hydrocone bowl protected by an ultra-durable, corrosion-resistant, fluoropolymer coating system from Tnemec. "The original tank's interior had a coal-tar epoxy that was falling off, extensive corrosion, and metal loss to the point that the tank was springing leaks in its side walls," Tnemec coating consultant Kevin Renslow explained. "The project involved the fabrication of a new tank and renovation of the original pedestal. After the new tank was welded together on a parking lot next to the existing structure, the old bowl was cut off from its pedestal and lowered to the ground by a crane. Then the new bowl was lifted into place and welded onto the original stem."

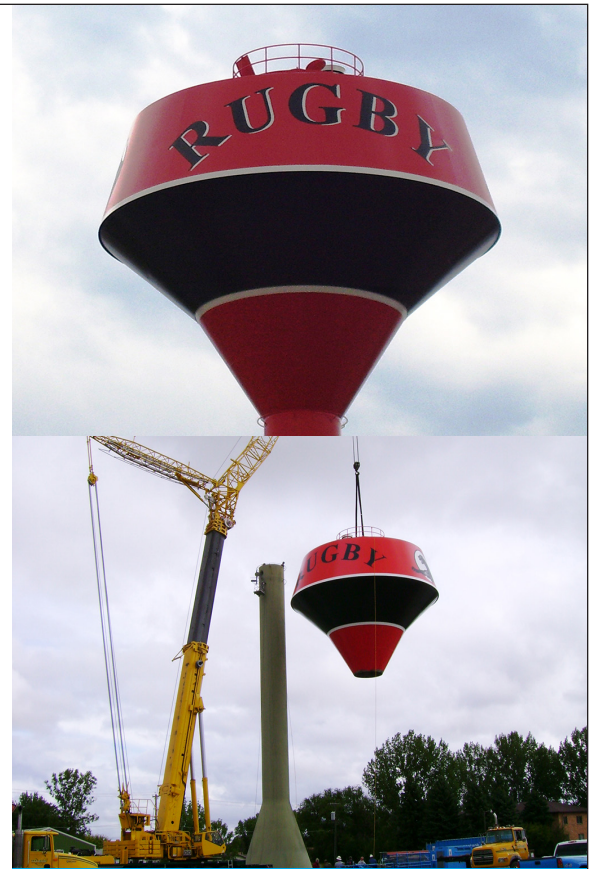
Series 700 HydroFlon protects the exterior of the Rugby, North Dakota water tank from the harsh effects of UV light.

Following assembly, the tank's interior received two coats of Series 20 Pota-Pox, a polyamide epoxy, which was spray-applied. Exterior steel received an intermediate coat of Series 73 Endura-Shield, an aliphatic acrylic polyurethane, which was roller-applied. A finish coat of Series 700 HydroFlon, an advanced thermoset fluoropolymer polyurethane especially designed for tanks and other exposed steel substrates, was brush- and roller-applied.

"Series 700 was specified for its long-term color and gloss retention and excellent resistance to ultraviolet (UV) light," Renslow added. "Artwork on the tank featured the Rugby High School's Panthers mascot and orange and black school colors, so a high level of aesthetics was also a must. After more than three years, the tank still looked like the day it was painted."
