CABELA'S ELEVATED WATER TANK

PROJECT INFORMATION

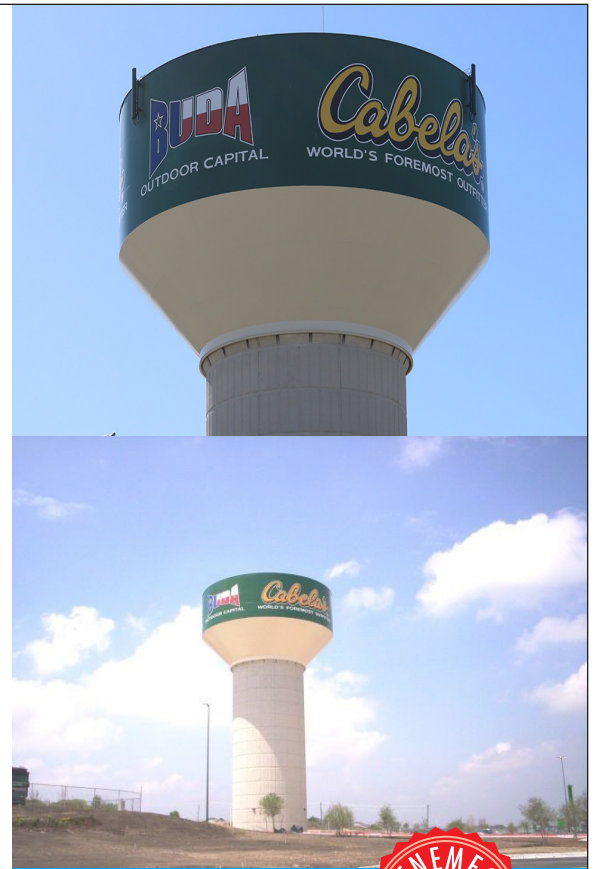
Series 700 HydroFlon, a fluoropolymer polyurethane finish coat, protects the exterior of the Cabela's water tank in Buda, TX, while Series 141 Pota-Pox 80, a high-solids polyamine epoxy, protects the interior.

The tank's exterior steel was prepared in accordance with SSPC-SP6/NACE No. 3, followed by a coat of Series 91-H₂O Hydro-Zinc, a moisture-cured, aromatic zinc-rich urethane primer. Series 91-H₂O was the first organic zinc-rich primer to be ANSI/NSF Std. 61 certified for use in potable water. An intermediate coat of Series 1075U Endura Shield II, an acrylic polyurethane, was then applied along with a topcoat of Series 700 HydroFlon, a fluoropolymer polyurethane. Chosen for its excellent color and gloss retention, Series 700 offers a life expectancy that surpasses traditional urethane topcoats.

After the interior of the tank was prepared in accordance with SSPC-SP10/NACE No. 2 and primed with Hydro-Zinc, Series 141 Pota-Pox 80, a high-solids polyamine epoxy, was applied to complete the interior coating system. A potable water coating that offers high-build edge protection and excellent corrosion resistance, Series 141 can be used on both steel and concrete tanks.
