# CABELA'S WATER TANK

When specifying protective coatings for a 500,000 gallon pedestal water tank outside Cabela's retail store in Tridelfhia, West Virginia, the project's engineer wanted a system befitting the 'World's Foremost Outfitter.' "The tank does double duty as a means of water distribution to the store and as a billboard to draw customers, so aesthetics were important," according to Tnemec coating consultant Sean Carlin. The engineers chose an exterior three-coat system known for its durability, color options, gloss retention and ease of application.

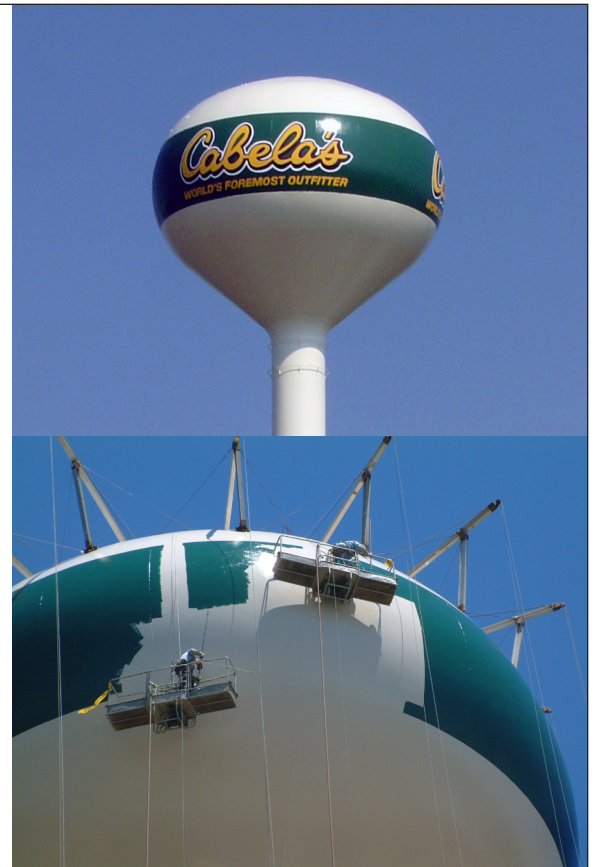
To protect the exterior of the Cabela's water storage tank in Tridelfhia, West Virginia, Series 700 HydroFlon was chosen for its excellent color and gloss retention.

Corrosion Control, the painting contractor for the Cabela's project, began work on the tank in the spring of 2004. The tank's interior and exterior exposed steel had already been primed in the shop by the tank fabricator with Series 91-H<sub>2</sub>O Hydro-Zinc, a two-component, moisture cured, zinc-rich urethane. The painting contractor began surface preparation by first using power tools to remove all weld spatter. The exterior of the tank was then spot abrasive blast cleaned in accordance with SSPC-SP6/NACE No. 3 and spot primed with Hydro-Zinc at 2.5 to 3.5 mils DFT. An intermediate coat of Series 73 Endura-Shield, an aliphatic acrylic polyurethane, was then applied at 2.0 to 3.0 mils DFT, followed by a finish coat of Series 700 HydroFlon, a fluoropolymer polyurethane, roller-applied at 2.0 to 3.0 mils DFT.
