KIRK ROAD HYDROPILLAR

There's no hiding a 209-foot-tall, 2 million gallon hydropillar that sits 30-feet from a major thoroughfare and is surrounded by a residential area, which is why engineers for the new water tank in Austintown, Ohio specified a coating system from Tnemec known for its high gloss and color retention. "The product engineer likes high performance and long service life from a coating system," according to Tnemec coating consultant Sean Carlin. "That's a real attribute of Series 700 HydroFlon, a two-component, fluoropolymer polyurethane. It provides a very high level of aesthetics, excellent application characteristics and superior ultraviolet light protection."

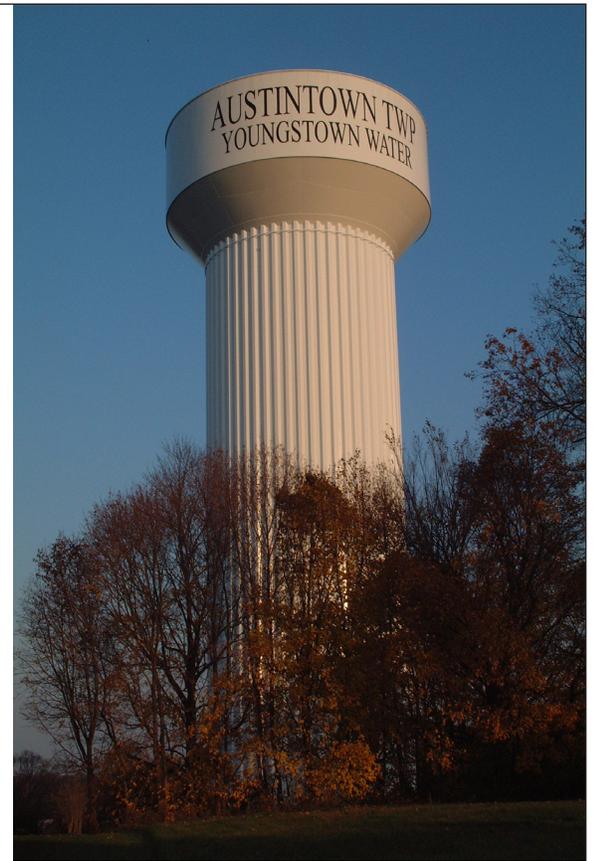
Chosen for the exterior of the Kirk Road Hydropillar in Austintown, Ohio, Series 700 HydroFlon is an excellent alternative to a four-coat system because it eliminates the need for a clear coat.

Following assembly, the tank's interior received two coats of Series 20 Pota-Pox, a polyamide epoxy, which was spray-applied. Exterior steel received an intermediate coat of Series 73 Endura-Shield, an aliphatic acrylic polyurethane, which was roller-applied, followed by a finish coat of HydroFlon that was also roller-applied. HydroFlon is an excellent alternative to four-coat systems since it eliminates the need for a clear coat.
