MELROSE HEIGHTS BOLTED WATER TANK

Built in 1925, the Melrose Heights 1.5-million-gallon water tank in Columbia, South Carolina, received a new lease on life after project engineers scrapped plans to replace the aging structure and chose instead to renovate it with a long-lasting coating system from Tnemec. "Everyone knew that this would be an extremely difficult coating project due to the tank being surrounded by houses, large trees, and busy streets," Tnemec coating consultant Dan Anderson acknowledged. "To make the difficult project even more challenging, the tank is a bolted construction with more than 25 legs. A typical water tank might have six legs, so there was several times the amount of steel on this tank than a typical elevated water tank."

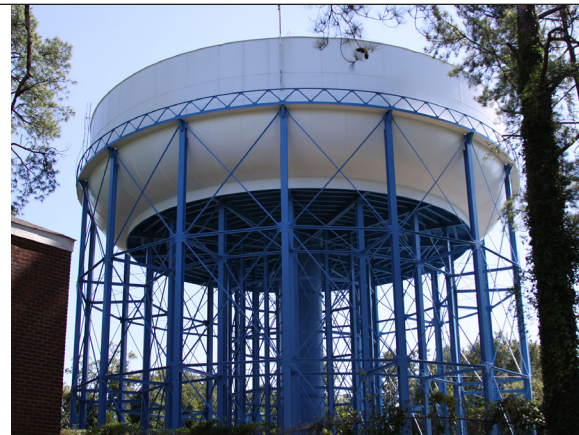
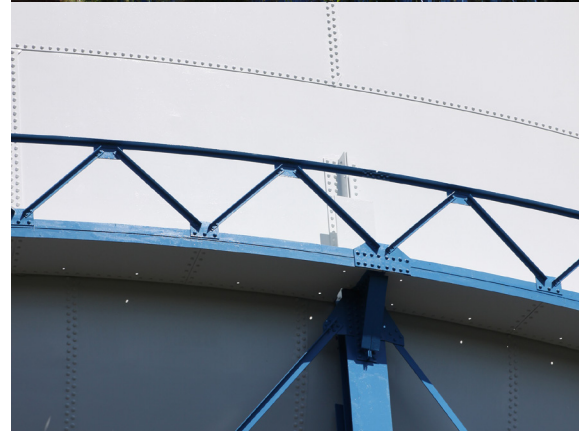
Over 500 gallons of Series 740 UVX added color and gloss protection for the Melrose Heights bolted water tank.

The tank's old coating system was chalking badly and its lower section was heavily corroded, so surface preparation consisted of SSPC-SP10/NACE No. 2 Near-White Metal Blast Cleaning for interior steel and SSPC-SP6/NACE No. 3 Commercial Blast Cleaning for exterior steel. "When the tank was painted 15 years earlier, blasting residue had gotten into nearby homes resulting in numerous complaints from neighbors," Anderson recalled. "This time, a containment system was built around the entire tank to prevent the spread of blasting residue, and as a result no complaints were reported."

Nearly 400 gallons of 94-H₂O Hydro-Zinc, a single-component, zinc-rich urethane primer, was spray-applied to both interior and exterior steel. Another 500 gallons of Series FC20 Pota-Pox, a fast-curing polyamide epoxy, were spray-applied to the tank's interior. "Due to the difficulty of coating all of the legs supporting the tank, the city wanted the coating system with long-lasting performance," Anderson noted. "So they specified the zinc primer with its outstanding long-term corrosion resistance on this tank, as well as two new 2-million-gallon elevated water tanks."

Nearly 600 gallons of Series 66 Hi-Build Epoxoline, a polyamide epoxy, were roller-applied as an intermediate coat on exterior steel, followed by a finish coat of Series 740 UVX, an advanced technology polyfunctional aliphatic urethane that offers superior color and gloss retention. The tank's upper bowl received 170 gallons of Series 740 in white, while the legs and bottom of the bowl used 350 gallons of Series 740 in blue.
