MIAMI COUNTY COURTHOUSE RESTORATION

In what has been described as the largest restoration of a cast iron facade in the U.S., the historic Miami County Courthouse in Troy, Ohio, required the judicious reconditioning of more than 15,000 ornamental and structural components using a long-lasting coating system from Tnemec.

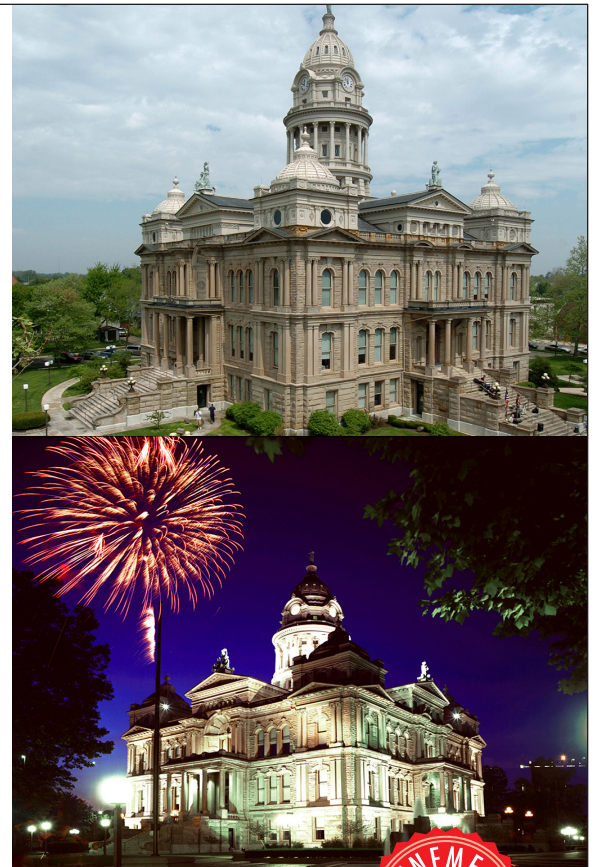
This historic courthouse located in Troy, Ohio was the sight of one of the largest cast iron restorations in the United States. With use of Tnemec coating systems, the courthouse has regained its beauty. Photos courtesy of Mike Ullery, Miami Valley Photography.

Reusable cast iron components were abrasive blast-cleaned to remove old coatings and shop-primed with Series 90-97 Tneme-Zinc, an advanced technology zinc-rich urethane coating. An intermediate coat of Series 161 Tneme-Fascure, a low temperature-cure polyamide epoxy, was also shop-applied. The same primer and intermediate coatings were used on replacement cast iron components created from hundreds of patterns custom-manufactured by Historical Arts & Casting to replace original parts that were severely corroded after decades of water intrusion.

The riveted iron framework used to support the cast iron cladding was field-coated with Series 135 Chembuild, a high-build modified polyamidoamine epoxy for marginally prepared rusty steel and tightly adhering old coatings. After the cast iron cladding was reinstalled, the exterior surfaces were field-coated with Series 73 Endura-Shield, an aliphatic acrylic polyurethane finish coating, which is highly resistant to abrasion, wet conditions and weathering. A clear coat of Series 76 Endura-Clear, an aliphatic acrylic polyurethane coating, was also applied to extend the long-term weathering properties of the Endura-Shield topcoat.
