STOVALL WATER TREATMENT PLANT

When Greenville Water needed to recoat some surfaces in the 20-year-old L.B. Stovall Water Treatment Plant in Travelers Rest, South Carolina, the project team was looking for coating systems that would last at least as long as the previous coatings, if not longer. The owners turned to the coating supplier they trusted most for their water tanks and treatment systems: Tnemec.

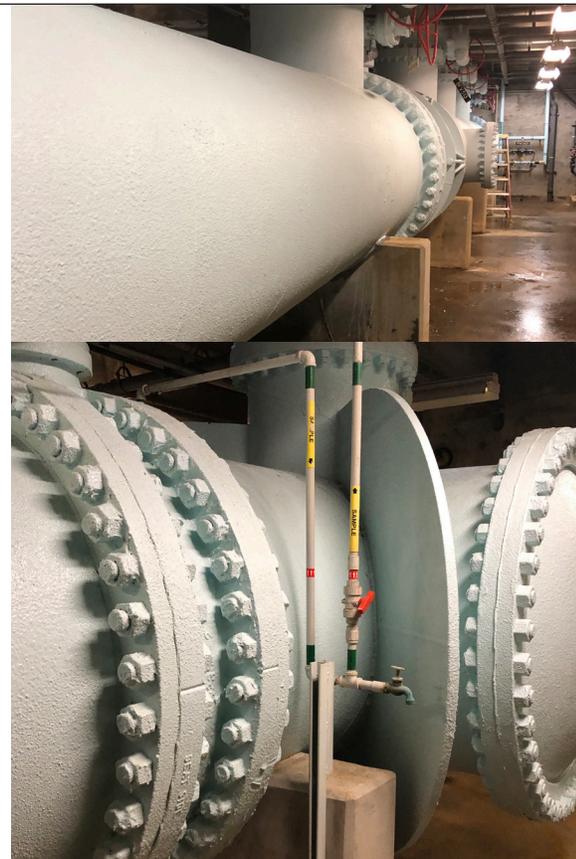
When local Tnemec representatives first entered this plant, the pipe gallery was full of condensation. Two coats of Tnemec’s insulating coating, Aerolon, and three years later, the pipes are corrosion- and condensation-free.

Piping in the basement areas were power washed and cleaned according to SSPC-SP 3 Power Tool Cleaning then primed using a surface-tolerant epoxy primer, Series 135 Chembuild. Following Series 135, two coats of Series 971 Aerolon Acrylic were applied to the pipes for a total of 80-90 mils DFT. A finish coat of the versatile, low VOC acrylic polyurethane, Series 72T Endura-Shield, was then applied at 3-5 mils DFT.

“Before the coating project, the piping was corroded, and water was constantly running off the pipes onto the floor,” explained Anderson. “But when I revisited it, there was no water anywhere and the piping was dry. Greenville Water is very pleased with the results.”
