HALLIDIE BUILDING RESTORATION

After decades of exposure to fog and moisture intrusion, the historic curtain wall façade of the Hallidie Building in San Francisco, California, needed mending with hundreds of restored or replaced metal components protected by advanced fluoropolymer coatings from Tnemec.

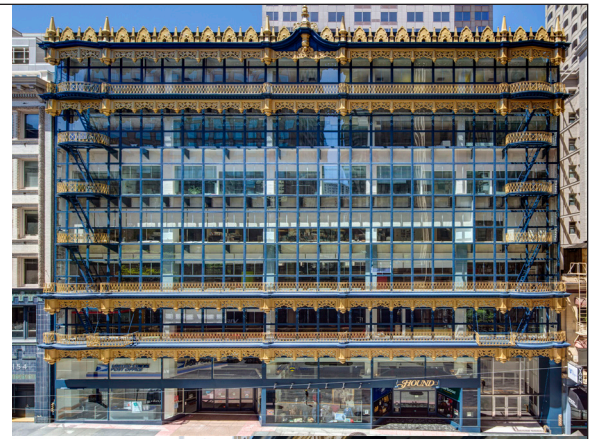
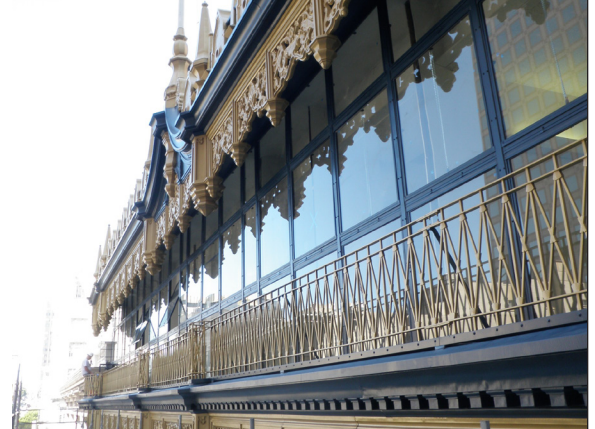
Coating systems from Tnemec helped to restore the historic Hallidie Building, in San Francisco, California, to its former glory. It was one of the first buildings in America to utilize the glass curtain wall structure. Photos courtesy Sherman Takata, Takata Photography.

The overall project involved removal, repair and reinstallation of approximately 735 sheet metal and railing components for the building’s ornamental balconies and fire escapes, along with 513 windows. Disassembly and removal of individual components was carefully monitored for compliance with environmental regulations related to the proper capture and disposal of lead-based paint. Existing paint on the façade was removed in blasting chambers by the coating applicator. Ornamental components were prepared in accordance with SSPC-SP6/NACE No. 3 Commercial Blast Cleaning, while window frames, sashes, metal grates and railings were prepared in accordance with SSPC-SP10/NACE No. 2 Near White Blast Cleaning. Each component was primed with Series 90-97 Tneme-Zinc, an aromatic urethane, zinc-rich primer.

Metalwork that required repair or fabrication was primed with Series 135 Chembuild, a modified polyamidoamine epoxy, which is an ideal foundation for the specified intermediate coat of Series 1075 Endura-Shield II, an aliphatic acrylic polyurethane coating. Nearly 235 gallons of Series 1075 was used.

More than 300 gallons of high-solids fluoropolymer coatings that offer outstanding color and gloss retention were applied as the finish coat to exterior metal, including structural steel. Blue-colored components received either Series 1071V Fluoronar, a low-VOC semi-gloss fluoropolymer coating, or Series 1072V Fluoronar, which offers a satin finish. Gold accented components received a coat of Series 1078 Fluoronar Metallic, followed by a coat of Series 1079 Metallic Clearcoat. “The advantage to this coating system is unsurpassed protection against ultraviolet (UV) light attack and the elements of weather, such as San Francisco fog,” Bowers explained.
