KAKFIA MAKAI WATFR STORAGF TANK

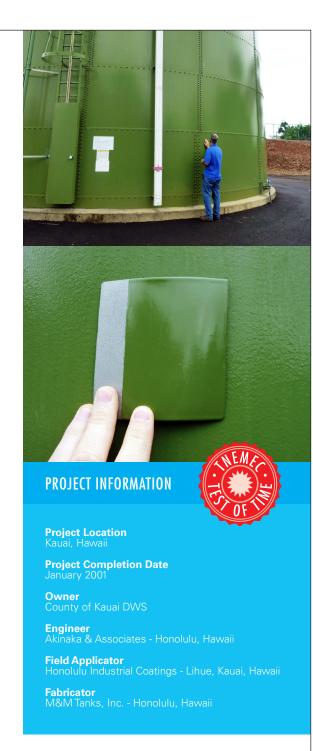
After almost 20 years of exterior weathering in tropical sunlight, hot weather, humidity and frequent rains, the gloss and color of the Series 700 HydroFlon topcoat applied to the Kakela water storage tank in Kauai, Hawaii, remain intact with no noticeable change. Photos shown were taken in 2011.
