## VILLAGE OF OAK LAWN

## ELEVATED WATER TANK

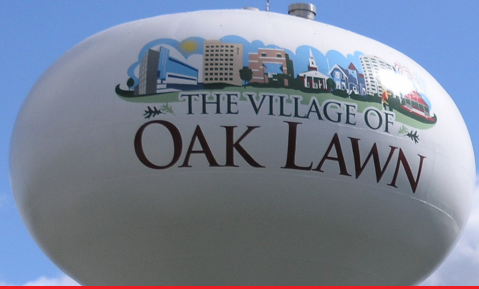
Upon entering the Village of Oak Lawn, Illinois, a visitor's first impression is of a manicured parkway surrounding a 1-million gallon waterspheroid embellished by a colorful mural made all the more impressive by the use of an advanced fluoropolymer coating system from Tnemec. "The mural is a collage of various buildings in Oak Lawn," explained coating consultant Erik Otten of Taylor Coating Sales. "The project was an overcoat of an existing coating system applied approximately 12 years ago."

The exterior of the tank was power washed in accordance with SSPC-SP12/NACE No. 5 *Surface Preparation and Cleaning of Metals by Waterjetting Prior to Recoating* to remove all loose paint and contamination. Failed areas were prepared in accordance with SSPC-SP11 *Power Tool Cleaning to Bare Metal* and spot primed with Series 135 Chembuild, a high-build polyamidoamine epoxy for use on tightly adhering existing coatings.

An intermediate coat of Series 1075 Endura-Shield II, an aliphatic acrylic polyurethane, was roller-applied to provide additional film thickness for corrosion resistance to all surfaces. A finish coat of Series V700 HydroFlon, an advanced fluoropolymer in the color Tank White, was roller applied to provide outstanding resistance to ultraviolet (UV) light degradation and unprecedented long-term gloss and color retention. "Fifteen different colors of Series V700 were used to create the streetscape mural," Otten noted. "Series V700 was specified to comply with current volatile organic compound (VOC) regulations in Illinois."

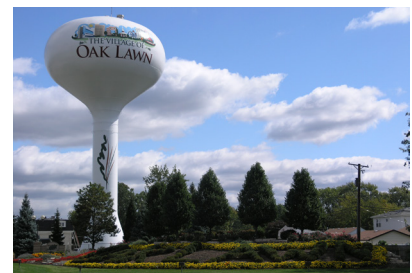
The elevated water tank in the Village of Oak Lawn, IL, was chosen from more than 140 entries as one of the 2011 Tnemec Tank of the Year runners-up. The tank stands protected with a coating system featuring HydroFlon.
