VENICE RENAISSANCE

PROJECT INFORMATION

Project Location
Venice, California

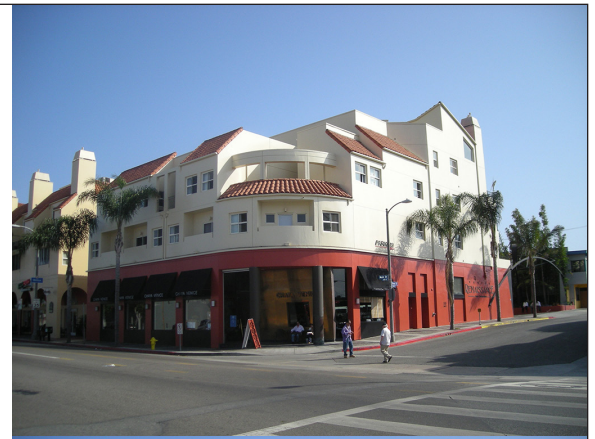
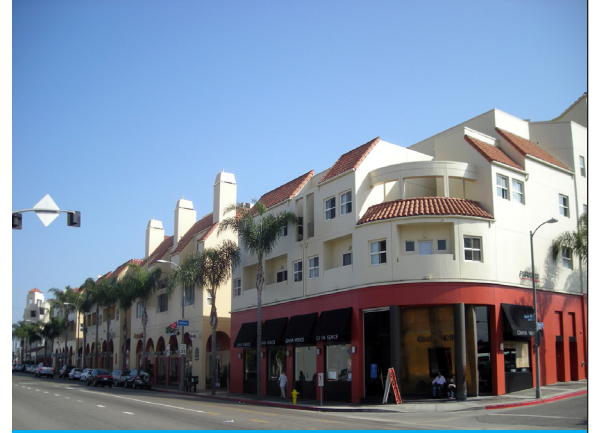
An acrylic coating that was originally used on the Venice Renaissance building did not withstand dirt and dust buildup from street traffic. Tnemec Series 1028 Enduratone was used to repaint the building in 2008 and the coating appears as it did when applied and can be easily cleaned.

The existing painted plaster substrate was pressure washed prior to coating. The project required nearly 200 gallons of Enduratone, which was matched to the original colors of the building and roller-applied. "After three years, the coating looks as clean as it did when it was applied," Hobbs acknowledged. "The maintenance people at Venice Renaissance have ordered Enduratone for areas that they want to touch up, so obviously they're coming back to Tnemec instead of the local paint store for touch-up paint."
