# WATER RESERVOIR RESTORATION

In the Regional Municipality of Halton in Oakville, Ontario, the restoration of a 23,500 square foot water reservoir created a ripple effect when similar projects in the area specified the same heavy-duty cementitious repair mortar and protective concrete lining system from Tnemec. "Besides this project, there are several other reservoirs in the area that have used the exact same lining system," according to coating consultant David Walker. "Overall, more than 200,000 square feet of concrete surface have specified this lining system to protect against corrosion from chemicals used to treat the water."

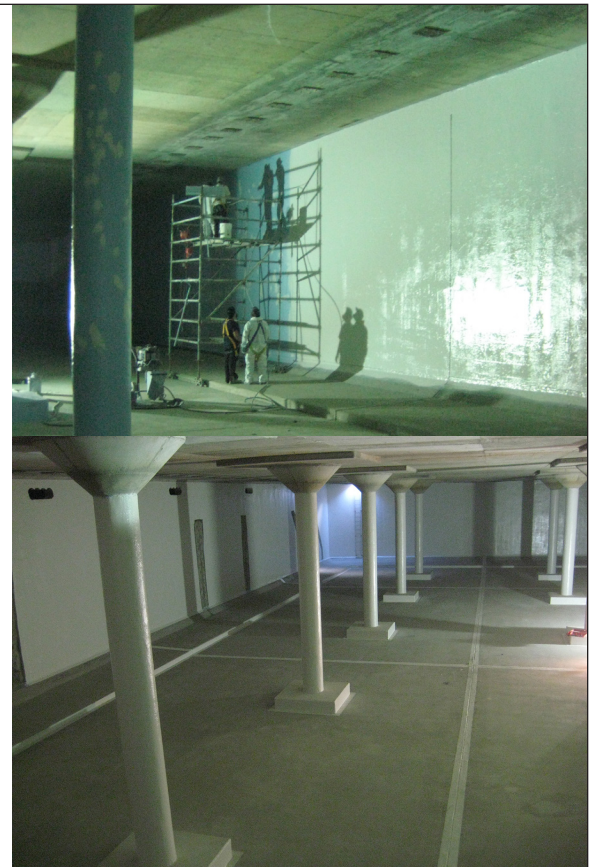
The deteriorated walls at the Water Reservoir Restoration in Oakville, Ontario, Canada were repaired using Series 217 MortarCrete.

Damage to two of the reservoir walls required the use of Series 217 MortarCrete, a single-component, cementitious repair mortar, specifically designed for heavy-duty repair of concrete surfaces. Series 217 was trowel-applied by hand, allowed to cure and then dry-abrasive blasted to achieve a SSPC-SP13/NACE No. 6 surface condition with a minimum profile of ICRI-CSP 5. It was then coated with Series 218 MortarClad, an epoxy-modified cementitious mortar, which was spray- and trowel-applied at 1/16 of an inch. Series 218 was also used on the reservoir's remaining walls, columns, footings and floors.
