# HALLIDIE BUILDING RESTORATION

After decades of exposure to fog and moisture intrusion, the historic curtain wall façade of the Hallidie Building in San Francisco, California, needed mending with hundreds of restored or replaced metal components protected by advanced fluoropolymer coatings from Tnemec.

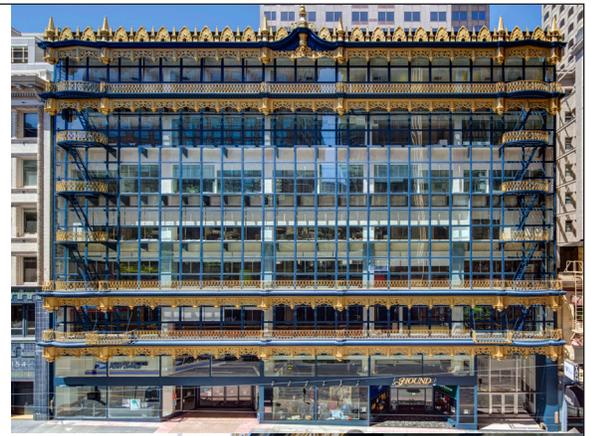
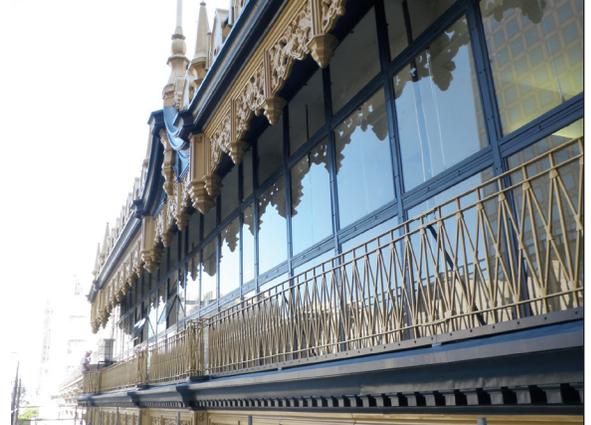
Coating systems from Tnemec helped to restore the historic Hallidie Building, in San Francisco, California, to its former glory. It was one of the first buildings in America to utilize the glass curtain wall structure. Photos courtesy Sherman Takata, Takata Photography.

The overall project involved removal, repair and reinstallation of approximately 735 sheet metal and railing components for the building’s ornamental balconies and fire escapes, along with 513 windows. Disassembly and removal of individual components was carefully monitored for compliance with environmental regulations related to the proper capture and disposal of lead-based paint. Existing paint on the façade was removed in blasting chambers by the coating applicator. Ornamental components were prepared in accordance with SSPC-SP6/NACE No. 3 Commercial Blast Cleaning, while window frames, sashes, metal grates and railings were prepared in accordance with SSPC-SP10/NACE No. 2 Near White Blast Cleaning. Each component was primed with Series 90-97 Tneme-Zinc, an aromatic urethane, zinc-rich primer.

Metalwork that required repair or fabrication was primed with Series 135 Chembuild, a modified polyamidoamine epoxy, which is an ideal foundation for the specified intermediate coat of Series 1075 Endura-Shield II, an aliphatic acrylic polyurethane coating. Nearly 235 gallons of Series 1075 was used.

More than 300 gallons of high-solids fluoropolymer coatings that offer outstanding color and gloss retention were applied as the finish coat to exterior metal, including structural steel. Blue-colored components received either Series 1071V Fluoronar, a low-VOC semi-gloss fluoropolymer coating, or Series 1072V Fluoronar, which offers a satin finish. Gold accented components received a coat of Series 1078 Fluoronar Metallic, followed by a coat of Series 1079 Metallic Clearcoat. “The advantage to this coating system is unsurpassed protection against ultraviolet (UV) light attack and the elements of weather, such as San Francisco fog,” Bowers explained.
