# 500,000 GALLON WATERSPHEROID

**Project Location**  
Waterville, Illinois

**Owner**  
City of Warrenville, Illinois

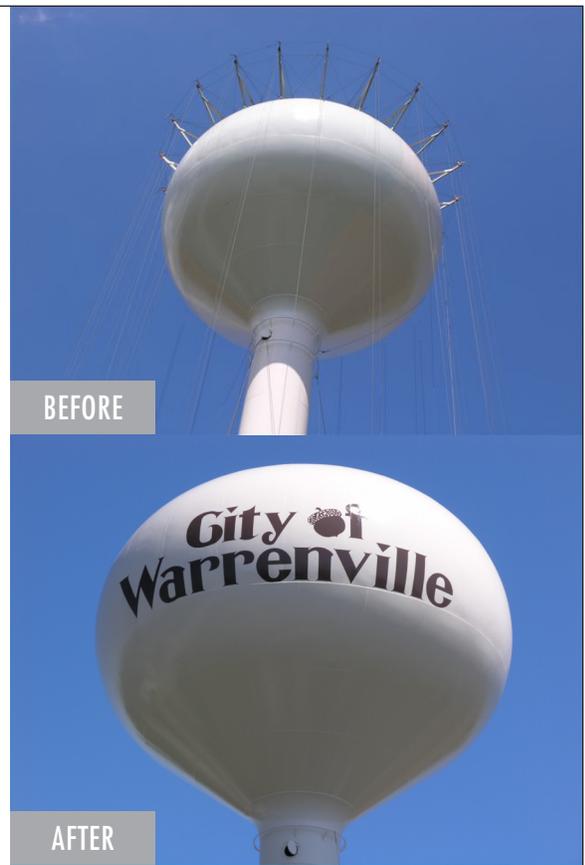
Tnemec's HydroFlon was chosen to protect the exterior of the Warrenville, IL waterspheroid because it offers superior long-term color and gloss retention.

The exterior of the steel water tank was prepared in accordance with SSPC-SP6/NACE No. 3 Commercial Blast Cleaning and primed with Series 91- H2O Hydro-Zinc, a moisture-cured, zinc-rich urethane primer. Next, an intermediate coat of Series 73 Endura-Shield, an aliphatic acrylic polyurethane, was roller-applied, followed by a topcoat of HydroFlon. "A containment system was required to collect the spent abrasive being used to blast clean the old paint off the tank," recalled Tnemec coating consultant Erik Otten. "The proximity of the pump station and building used to house antennas directly beneath the tank made the containment more difficult than most water tank repainting projects."

In addition, the tank's interior steel received a spray-applied prime coat of Hydro-Zinc following surface preparation in accordance with SSPC-SP10/NACE No. 2 Near-White Metal Blast Cleaning. Two coats of Series FC20 Pota-Pox, a fast-curing polyamide epoxy, were spray-applied to complete the interior coating system.
